ST JOSEPH'S CHURCH HOBART CONSERVATION MANAGEMENT PLAN VOLUME 1 OF 2 • THE PLAN

prepared for
ST JOSEPH'S CHURCH HOBART BY
PETER FREEMAN PTY LTD • CONSERVATION ARCHITECTS & PLANNERS
in association with
MARY KNAGGS • HERITAGE ARCHITECTURE & TOWNSCAPE
DONALD ELLSMORE PTY LTD • HERITAGE CONSULTANT
SHIRLEY KING • HISTORIAN & CLAIRE SKEGGS • HISTORIAN
FINAL
JANUARY 2006

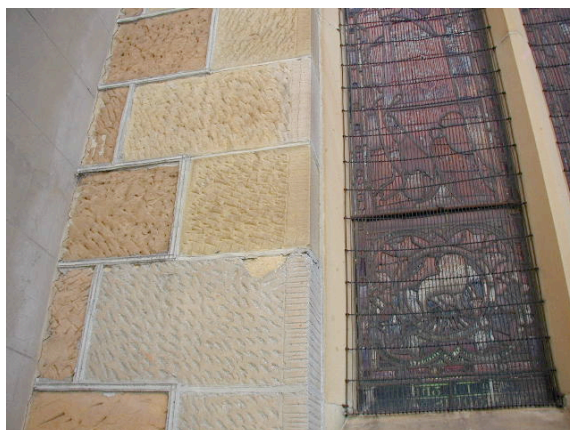
Figure 4.6
Typical side elevation
showing sparrow picked
stonework with raised
cement mortar joints. Note
delaminating stone. **2005**

Much of the sparrow picked stonework on the side elevations of the church has been re-pointed in cement mortar. This probably occurred c1970. It is now well known that such strong mortar accelerates disintegration of sandstone and promotes salt attack. Lime based mortars should be used weaker than the surrounding stone so that moisture and salts can evaporate through the mortar, which is more easily replaced than the stone. The re-pointing is also unsightly.

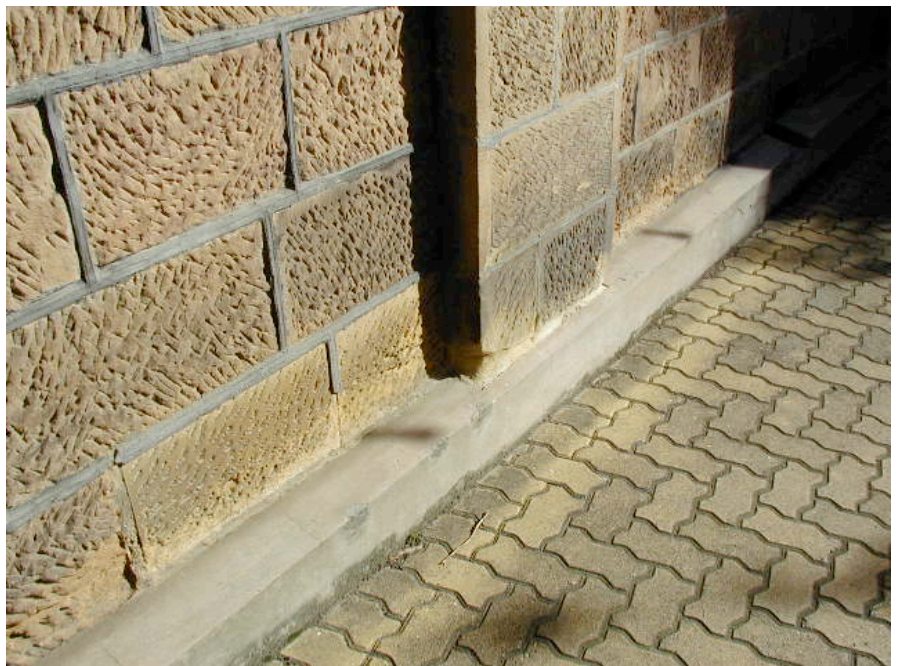
Figure 4.7
Typical side elevation showing sparrow picked stonework with rendered plinth and hard cement paving. Note stone decay above plinth line. **2005**

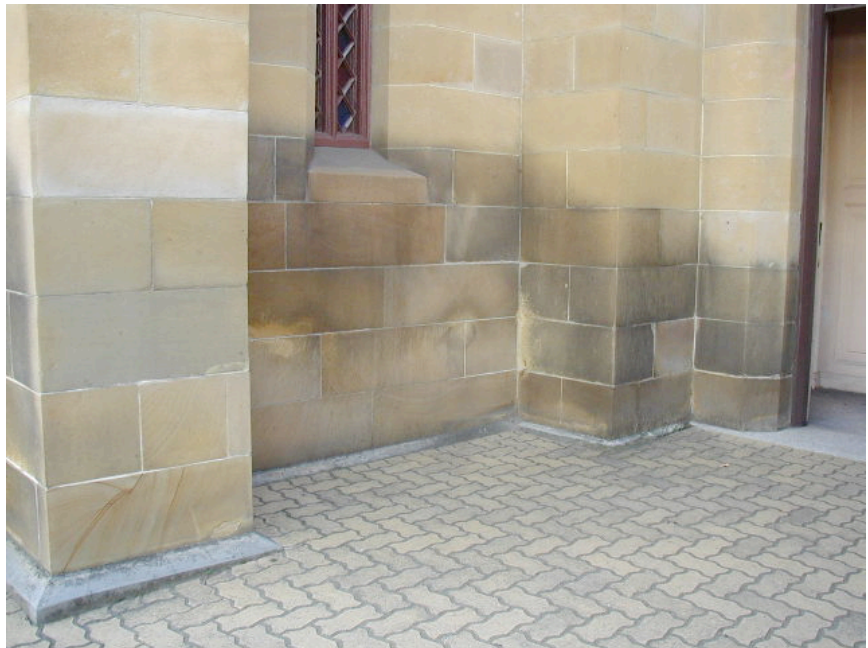
Figure 4.9
Area of badly discoloured
stone adjacent to disabled
access entrance. 2005

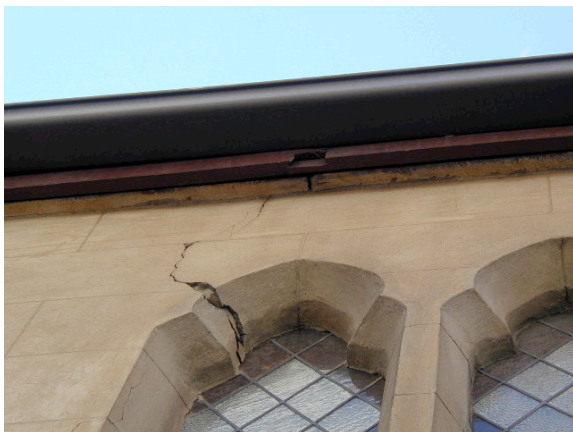
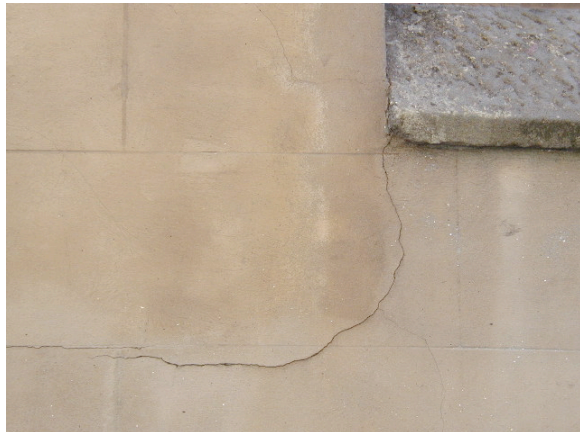
Figure 4.15
Typical cracking pattern
2005

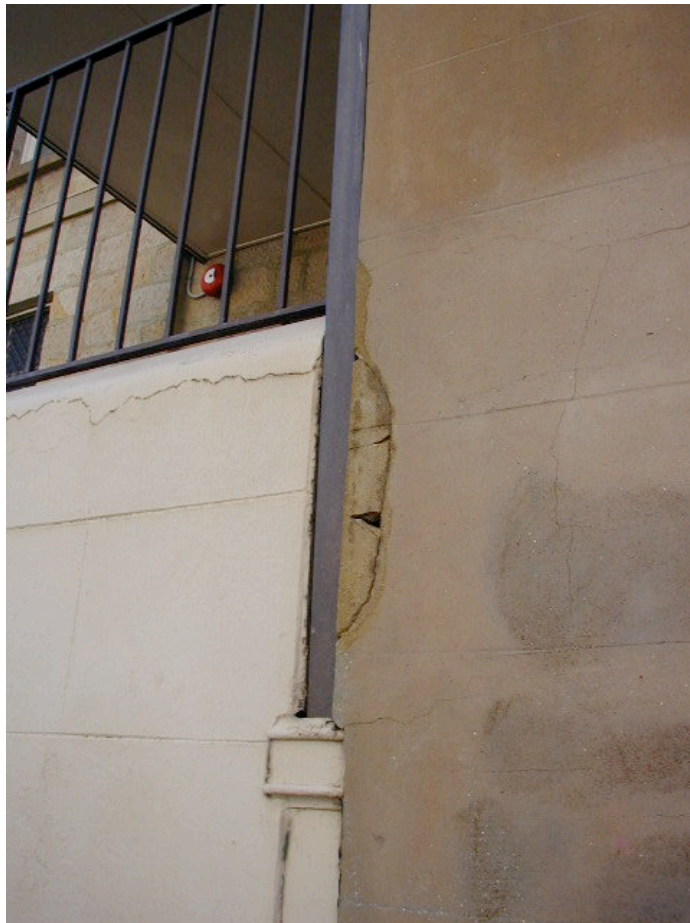
The lower courses of the wall have been continually subject to graffiti and have subsequently received a [cementitious?] paint finish [and possibly anti-graffiti coatings?]. These lower levels are also quite stained and have fine horizontal cracks. It is also likely that some render will delaminate along lower levels of Harrington St wall in the near future. Render is spalling in the upper left hand corner of one of the windows.

Figure 4.16 Cracking at the corner in the Sacristy render and over-painting to conceal graffiti. **2005**

Removal of all the render appears to be the only solution. Given the loose stone was 'chipped back' prior to the application and the obvious presence of damp in the wall, removal may reveal that the stone is so deteriorated that it will be necessary to apply a new soft lime based render. It is recommended that some test area of render removal be carried out first to assess the amount of damage to the stone below.

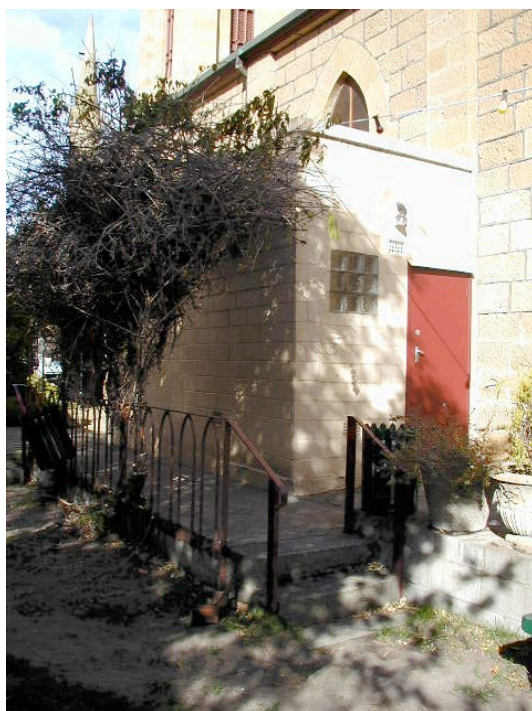
Figure 4.18
Confessional structure from NW. The wisteria has since been removed accentuating the intrusive nature of the materials & form. **2005**

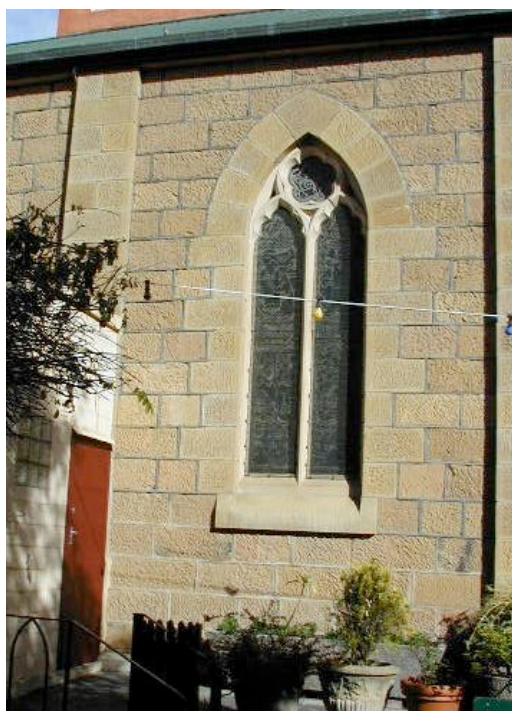
Figure 4.39
Exterior window head
detail. If secondary glazing
is required it should be cut
around the stone tracery.
2005

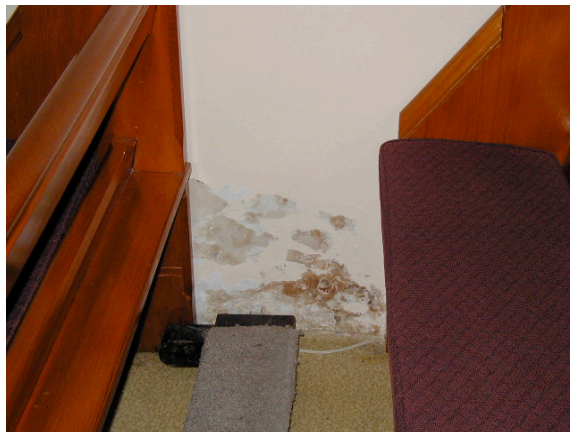
Figure 4.40
Rising damp and salt
decay on the north wall of
the Nave. 2005

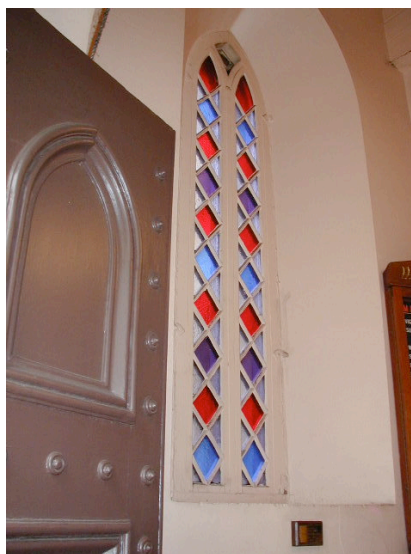
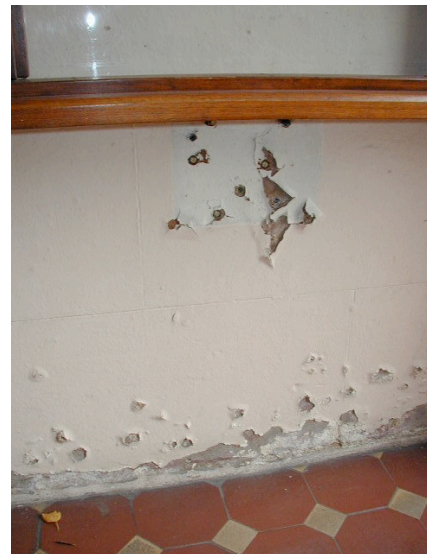
The paint is peeling near floor level and evidence of salt attack to stone. This problem is also evident on exterior face of wall including erosion of face stone and algal growth.

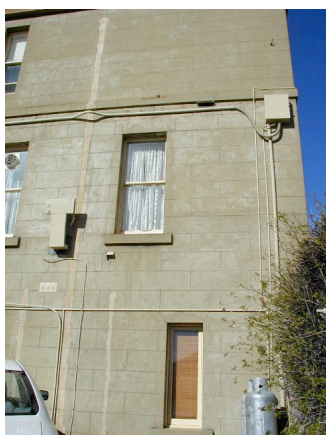
Figure 4.68
 West facing elevation of Monastery showing render finish and intrusive externally mounted services.
