ST JOSEPH'S CHURCH HOBART CONSERVATION MANAGEMENT PLAN VOLUME 1 OF 2 • THE PLAN

prepared for
ST JOSEPH'S CHURCH HOBART BY
PETER FREEMAN PTY LTD • CONSERVATION ARCHITECTS & PLANNERS
in association with
MARY KNAGGS • HERITAGE ARCHITECTURE & TOWNSCAPE
DONALD ELLSMORE PTY LTD • HERITAGE CONSULTANT
SHIRLEY KING • HISTORIAN & CLAIRE SKEGGS • HISTORIAN
FINAL
JANUARY 2006

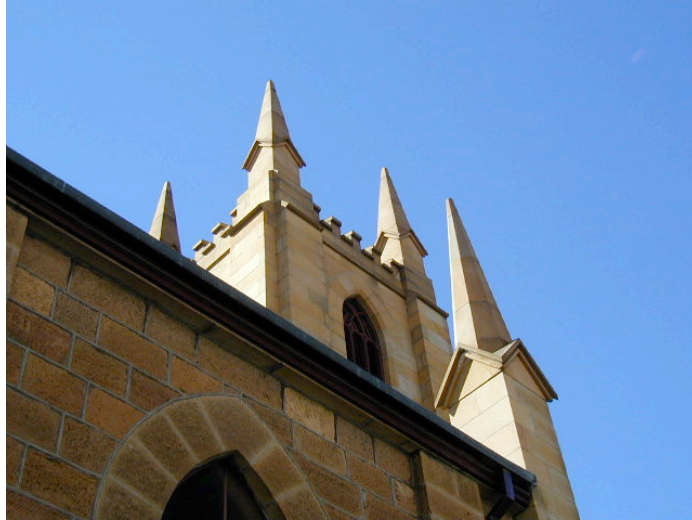
Figure 4.5
View of the St Joseph's
turrets from Harrington
Street. **2005**

Despite this extensive conservation program, areas of the ashlar stone continued to delaminate and a further program of stone repairs was carried out in 1988. This program involved some epoxy injection and artificial coloured stone facings. Both of these programs were carried out by Marco Rizzolo and his son [now Heritage Stone, run by Marco's grandson, Brad Rizzolo]. Brad commented that the 1970s stone used was probably Campania Stone and in the 1980s Linden Stone from near New Norfolk. Much of the 1970s replacement stone has pronounced banding, which detracts from the aesthetics of smooth ashlar coursing.

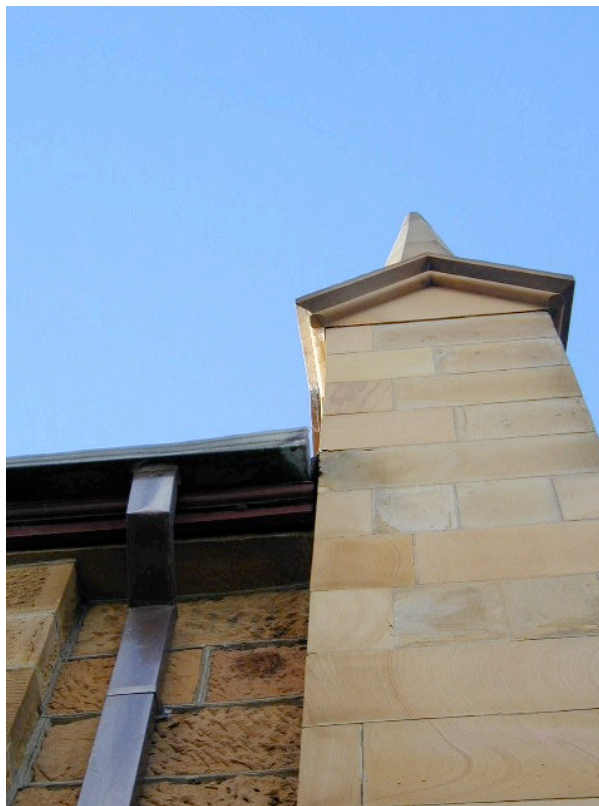
Figure 4.8

Stone buildings require a cyclical maintenance program of re-pointing at least every 15 years. Joints without mortar allow water in behind the stonework, accelerating decay. From ground level it can be established that about 30% of the smooth ashlar facade needs re-pointing including most

Part of the south elevation showing the loss of mortar from jointing, and some inappropriate banded stone used in previous repairs. **2005**

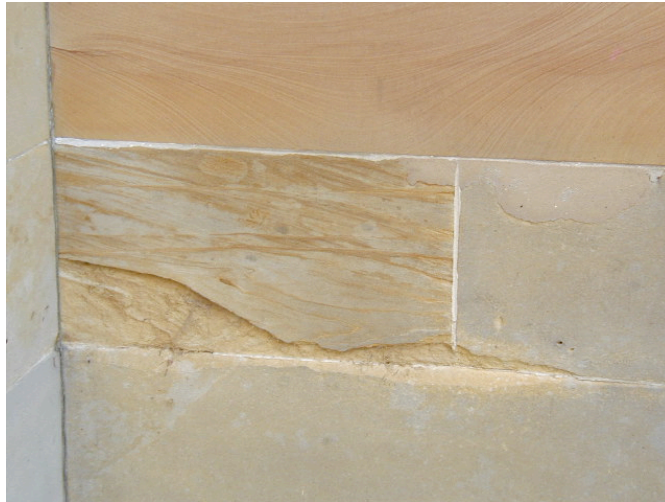
Figure 4.10

Two c1970 indents with badly matched stone with pronounced banding. One indent now spalling. **2005**

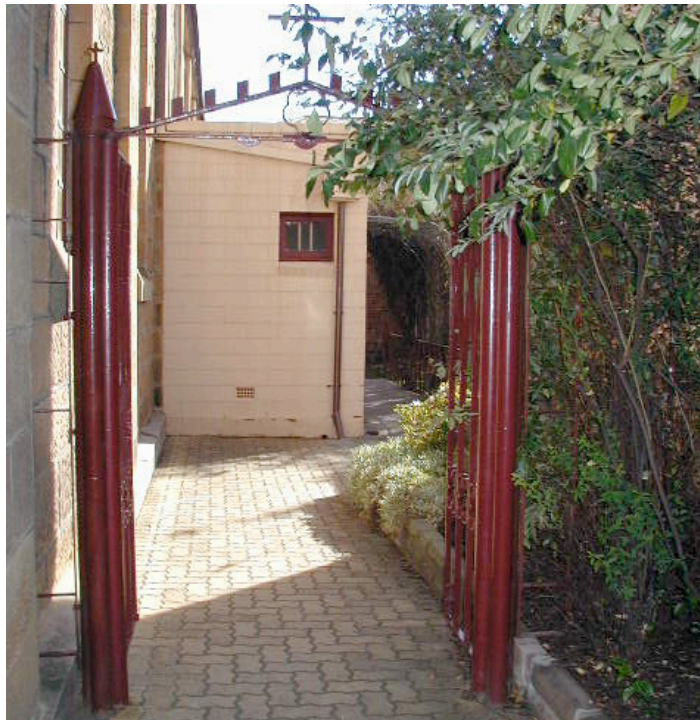
Figure 4.17
The Confessional addition
c1959, looking from the
from Macquarie Street
entrance.
2005

The courtyard is now considered a great asset to the church and has the potential to be a spiritual refuge with a landscape that is contemporary but which compliments the heritage value the Church [see Landscape Analysis below]. The flat roofed form and materials of the Confessional structure form a jarring element when entering the courtyard, confining the space and preventing views of the church in its entirety and through to the chapel. The confessionals in this context and in an assessment of the overall heritage presentation of the site can be considered to be **intrusive**.

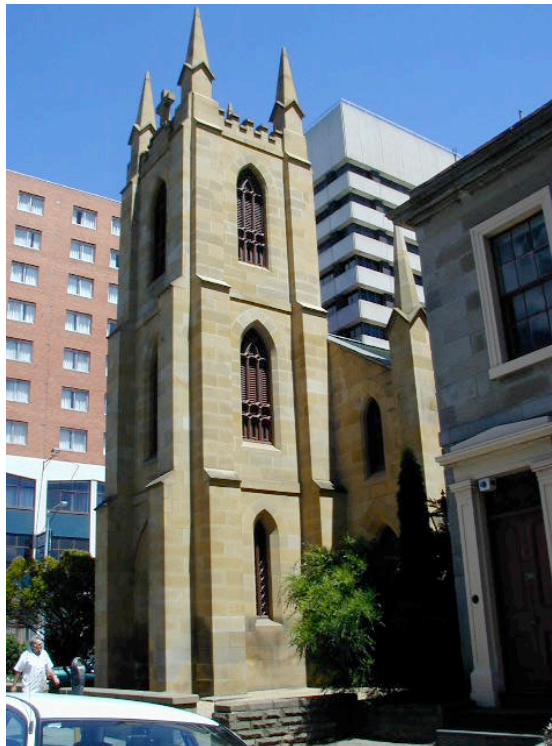
The exterior of the tower roof was not accessible as part of this assessment. However access to the underside reveals that it is likely to be a waterproof membrane [lead?] over the timber boarding exposed below. These timber boards show signs of deterioration through falling damp.

Figure 4.19
St Joseph's Tower 2005

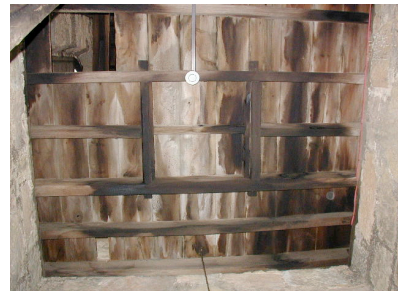
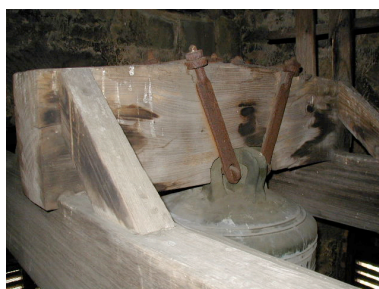
Figure 4.21
View of the underside of
the belfry floor. 2005

Figure 4.21
View of the bell support
structure. 2005

There is a manhole with a timber-framed cover and lead flashings. The downpipe from the tower roof is internal until it passes through one of the timber screens and discharges onto the main church roof. There is evidence on the intermediate belfry floor below of localised falling damp suggesting that the roof drainage system overflows on occasion.

The tower should be re-roofed in a suitable long life membrane system. The existing tower roof and floor timber structures should first be checked by a structural engineer and repaired as required. The roof drainage system should also be checked and repaired. [P3]

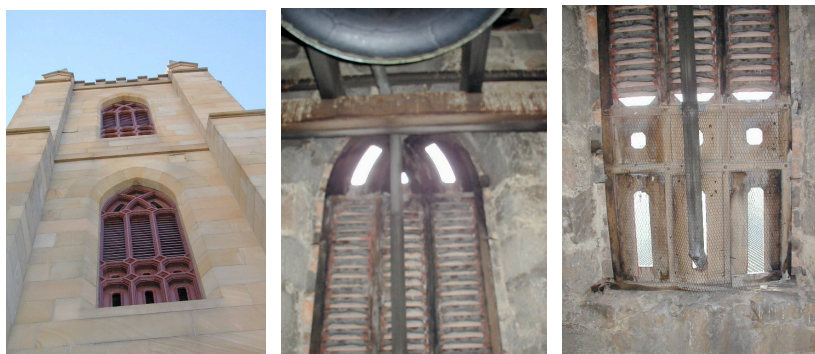
Figure 4.23

Views of the inside and outside of the tower windows. Internal views also show the internal 2005 copper downpipe.

The louvre sections are a later addition to minimise water ingress into the tower. They do not appear in the c1878 photograph [Figure 8 in the Illustrated Chronology] but were in place by 1914 [Figure 18].

The exteriors of the windows are painted and the surface is in reasonable condition suggesting a recent application. The internal surfaces are unpainted and, although water stained, are in reasonable condition, with the exception of the sills and adjacent timbers.

Bird-proofing to the tower is by way of galvanised mesh tacked to the inside face of the windows. This system has failed in places and there is evidence of a resident bird population. Although a reasonable solution, the continuous replacement and repair of the mesh results in damage to the timber of the windows.

The timber sills and adjacent timbers of the tower windows should be repaired or replaced as required. New flashings damp proof courses [dpc] should be incorporated. [P1]

The bird proofing to the tower windows should be renewed with a new system that contains stainless steel mesh within its own stainless steel angle frame. [P2]

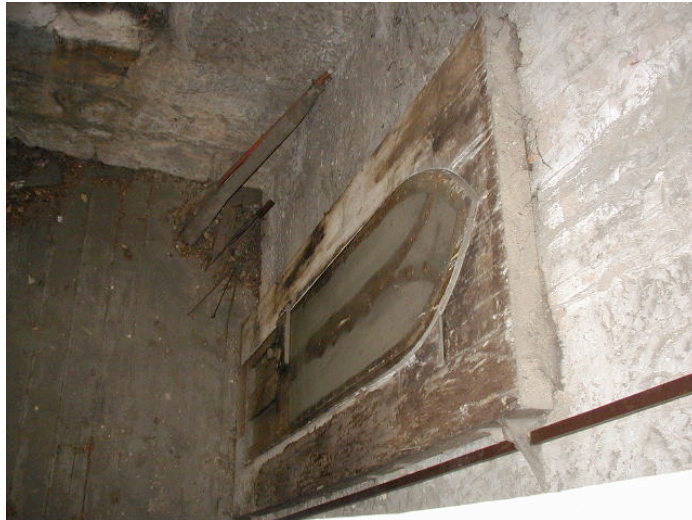
Figure 4.24

The tower access door viewed from the tower interior. The tower timber joinery is intact early fabric and should be carefully conserved. **2005**

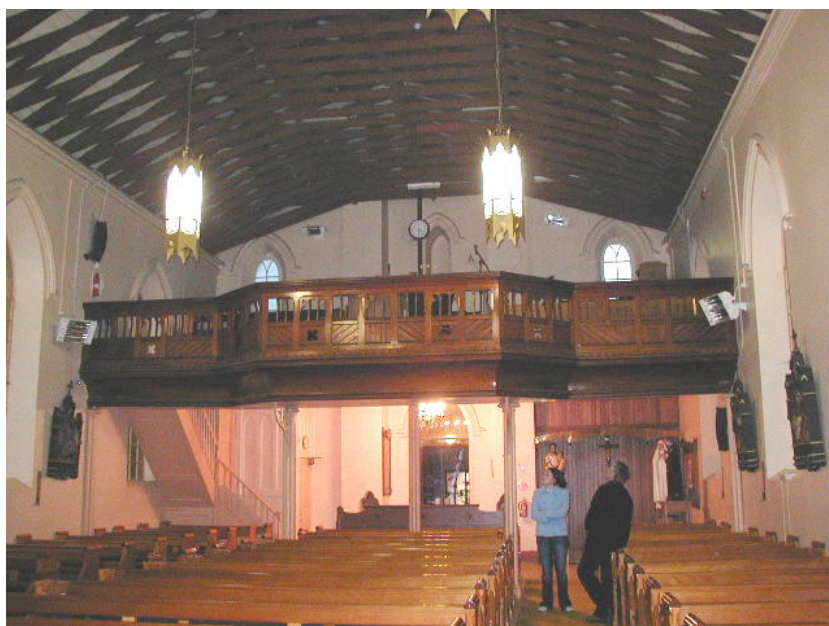
Cream wool carpet to Sanctuary and central carpet with metal trim to circulation spaces and vinyl clad acoustic sheet floor covering under pews. The floor of the nave is covered in patterned linoleum with worn brown carpet down the two side aisles. Floor finishes look tired and do not help interpret or enhance heritage qualities of the church. Skylight lining shows some signs of falling damp this could be canvas lining over original boarding.

Figure 4.26
View of the eastern end of
the Church interior. **2005**

Decorative paintwork on skylight reveals can be made out, probably from the 1856-59 Bishop Willson interior. Electric lights were made in 1971 by Phillips Industries in Melbourne². Traffic noise from Macquarie Street is still a problem within the Church.

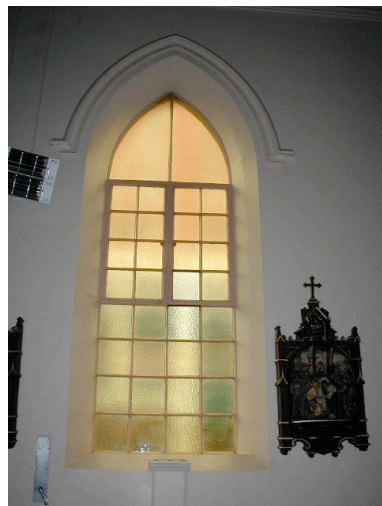
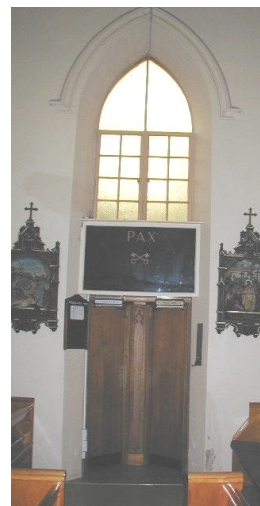
Figure 4.32
Window W2. 2005

Figure 4.33
Window W8. 2005

The current operable sashes may be useful for providing natural ventilation to the Church. Overall the windows are of low heritage significance. Window W8 is over the access door to the confessionals. Between the window and the door is a sign showing when the confessionals are in use. This confessional sign is intrusive.

Elsewhere it is recommended that the confessionals be demolished and new confessionals provided elsewhere. This would give an opportunity to provide a door from the church out onto the Courtyard garden. Removal of this confessional would also improve the presentation of the church. New confessional indicators could be subtly designed to suit their new location.

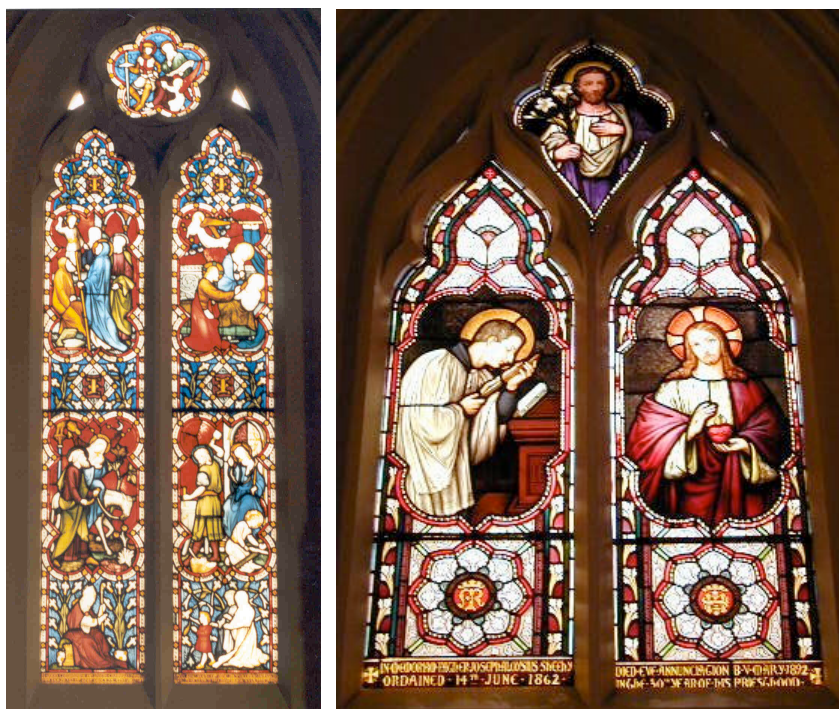
Figure 4.36 left
 Window W6. 2005

Figure 4.37
 Window W7. 2005

considered sending a damaged panel back to the Hardman Studio near Birmingham UK for repair. Cummins and Stehn have noted that the windows are structurally sound but have some conservation requirements.

- Fully clean and restore the Hardman 'Life of Joseph' windows;
- Clean in-situ both the 'Annunciation' and 'Sts John and Joseph' Hardman windows of the corrosive linseed oil currently on their surface;
- Instate or reinstate reinforcing bars to the existing windows;
- Install glass protectors [use wire ones until then];
- Fully restore the 'Annunciation' window if funds are available; and
- Remove the distracting less skilled Brooks Robinson window from the base of 'Annunciation' window.

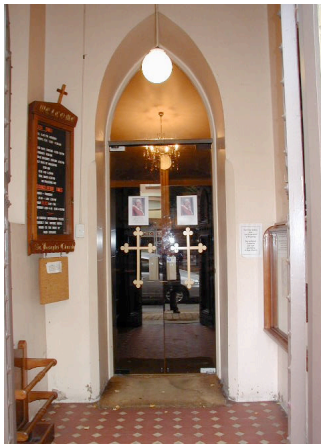
Figure 4.41
Front porch & glazed doors.

Paint should be removed from the stone walls in both the main entrance porch and the disabled access porch to a suitable height [1.2m?] and a sacrificial render applied. [P1]. Following [external] remedial action to arrest damp in stone the sacrificial lime render can be removed and the both porches should be redecorated throughout based on an investigation of early finishes. [P3]

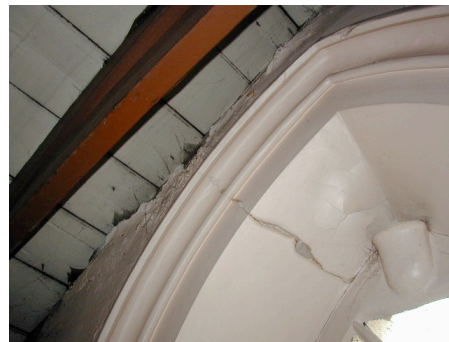
Figure 4.52
Cracking in Window reveal
Wx from Gallery level.

The Gallery space appears somewhat chaotic in its use and presentation. It would appear that only the organist and choir have occasion to access the Gallery. The remainder of the time it is kept locked. There are wall cracks in SE corner around windows. Paint peeling around window in NE corner.

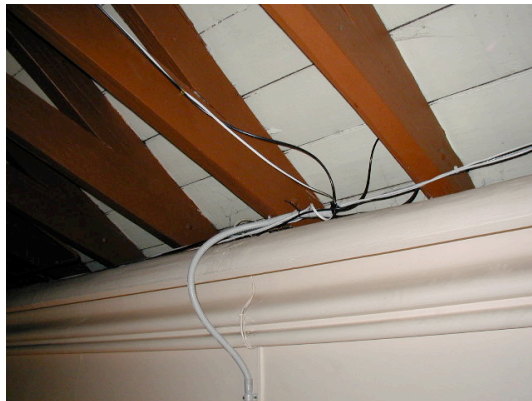
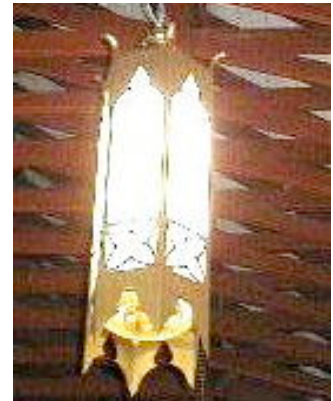
Figure 4.53
Some of the loose surface wiring visible at Gallery level.

Figure 4.54
Light fitting

Currently the church nave is lit by six large brass gothic-style light fittings with opaque glass suspended from the roof trusses. *Contributory significance.*

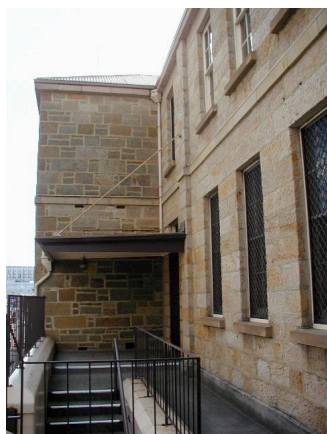
The concrete steps, at the main entrance to the Monastery are practical but unwelcoming and detract from the heritage values of the property. The entrance porches are very practical but are not particularly sympathetic to the heritage presentation of the building. For example the Main entrance canopy cuts across the door opening. There are expanded aluminium security screens to doors and windows at the two lower levels. Although practical the screens detract from the heritage values of the building.

Figure 4.67
 View of main entrance terrace looking west.

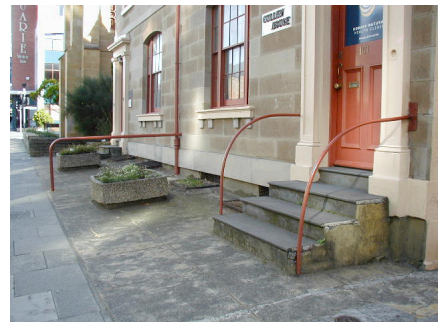
Figure 4.73
Front landscape detail.

The front of Cullen House appears to have been landscaped c1970 with the removal of any front allotment delineation and the provision of pre-cast concrete planter boxes. Inappropriate curved steel pipe handrails are provided either side of the entrance steps.

The street frontage to Cullen House should be redesigned by a professional landscape architect, to compliment the heritage significance of the property and the precinct. This should occur at the same time as the Church courtyard landscape redesign.

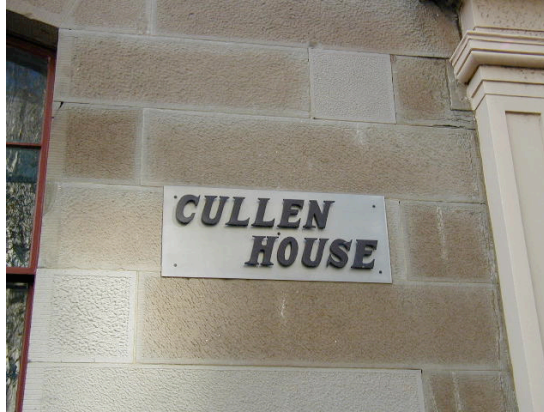
The current signage is piecemeal and the style of the 'Cullen House' detracts from the heritage significance of the Building.

Figure 4.74 left
Cullen House Sign

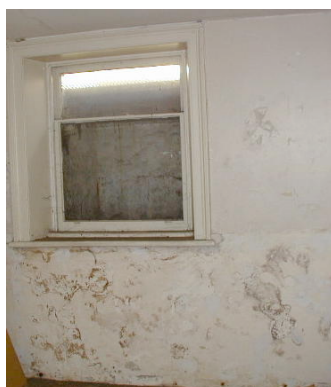
There is an extreme rising damp problem in the basement of Cullen House which means these areas are no longer in use except for non-critical storage. Bad rising damp is also in evidence on the south corridor wall at ground floor. The rising damp problems are probably exacerbated by the hard paving against external walls and by the watering of planter beds.

Figure 4.78
Basement rising damp.

The planter bed immediately to the south of 163 Macquarie Street should be removed as part of the re-landscaping of the Church courtyard. This will alleviate the internal rising damp problems on that wall.

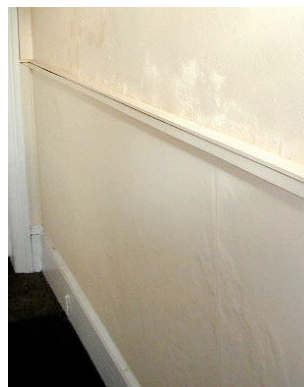
Figure 4.79
rising damp in ground floor
corridor south wall

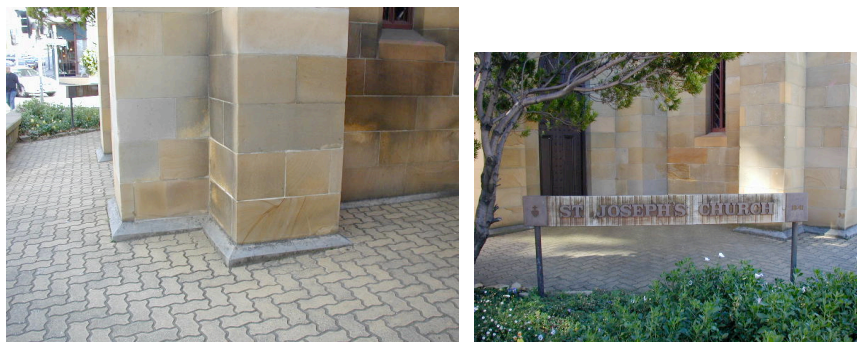
The current paving around the front and sides of the Church is interlocking herringbone concrete paving. The Analysis of external fabric recommends that the paving is removed from immediately against the Church walls as it is preventing moisture evaporation from the ground forcing the sandstone to act as a wick for moisture and accelerating salt decay of the stone. In addition the small unit shaped paving is too fussy for the simplicity of the Church. **The current paving is intrusive to the heritage qualities of the Church.**

Figure 4.85
 Paving detail 2005

Figure 4.86
 Existing Church sign

The current free standing Signboard was erected in 1982. It is now dated and dirty and difficult to read. Attached to the Church side entrance is further signage which allows for changing Mass times and other information. The positioning of this sign is misleading as to which is the main entrance to the Church.

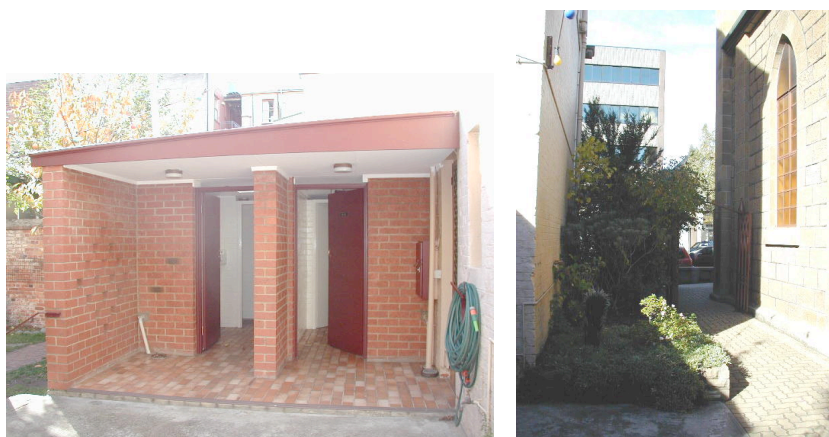
Figure 4.90

Starting at Macquarie Street the planting bed on the right is causing rising damp and salt decay problems within Cullen House [163 Macquarie St].

The planting on the left is contributing to rising damp in Cullen House. Opening this up would also provide a more welcoming entrance to the courtyard.

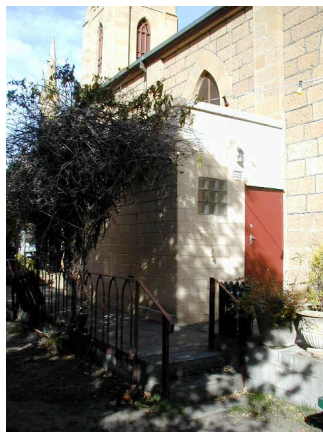
Figure 4.91

The confessionals are intrusive to both the Church and the Courtyard

<p>Priority 3: Action within 5 years</p>	<p>Policy Recommendation No 9: The Confessionals</p> <p>In the longer term new reconciliation rooms should be created within the Church or the Sacristies and the existing Confessional Structure removed. In addition to the removal</p>

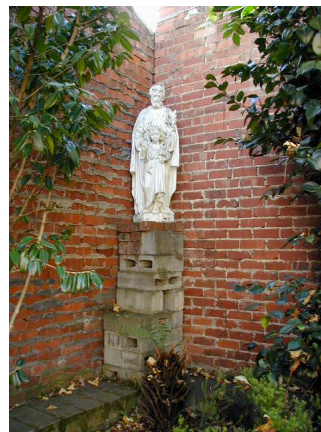
Figure 4.92

The statue of St Joseph is of significance and deserves better presentation.

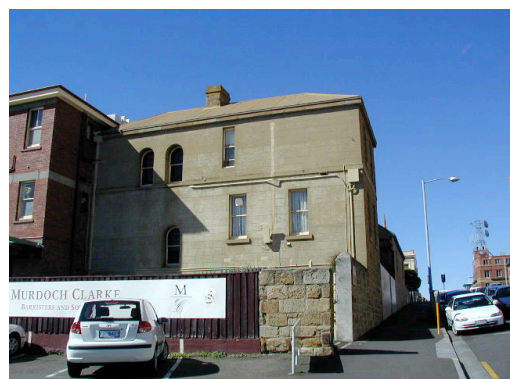
Figure 4.94

Views of the western boundary fence from the Harrington St footpath to the west.

The Gate to the carpark area off Harrington St is inadequate and possibly rarely used. The remainder of the boundary to the property to the west has a capped and lapped timber fence is in poor repair and is unsightly. It is used by the neighbouring property for a large 'business naming' sign. Signage Board to carpark entry is shabby. Renew as part of new signage for whole precinct. Ditto signage to carpark and Monastery entrance. Consider integrating intercom system into new signage beside Monastery entrance.

A new fence to the western boundary should be designed concealing more of the carport area and providing better security and overall presentation.

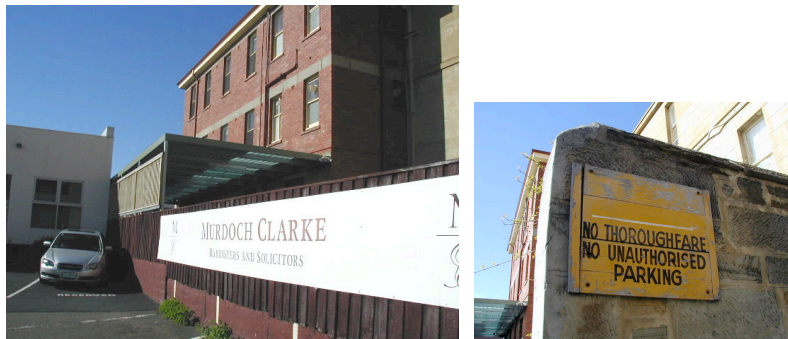
Figure 4.95
View of the Monastery carport from the Harrington St footpath

Figure 4.96
One of the many signs in the area.
