ST JOSEPH'S CHURCH HOBART  
CONSERVATION MANAGEMENT PLAN  
VOLUME 2 OF 2 • APPENDICES

PREPARED FOR  
ST JOSEPH'S CHURCH HOBART BY  
PETER FREEMAN PTY LTD • CONSERVATION ARCHITECTS & PLANNERS  
IN ASSOCIATION WITH  
MARY KNAGGS • HERITAGE ARCHITECTURE & TOWNSCAPE  
CLAIRE SKEGGS • HISTORIAN &  
DONALD ELLSMORE PTY LTD • HERITAGE CONSULTANT

FINAL  
JANUARY 2006

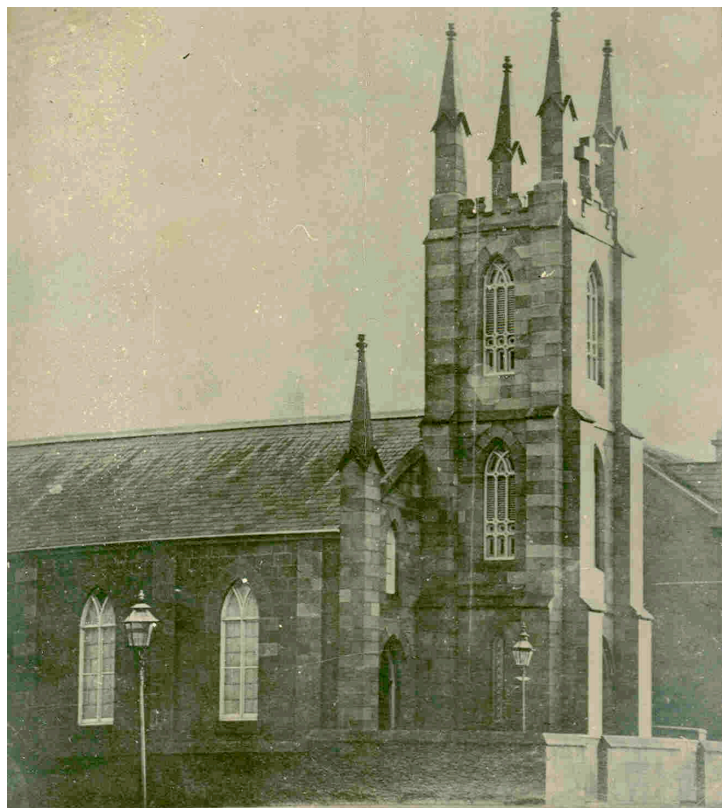
**Figure 14**

'St Josephs Harrington Street', Not dated, but c1890. Note the masonry wall to the Street frontage. *StJ Archive*.

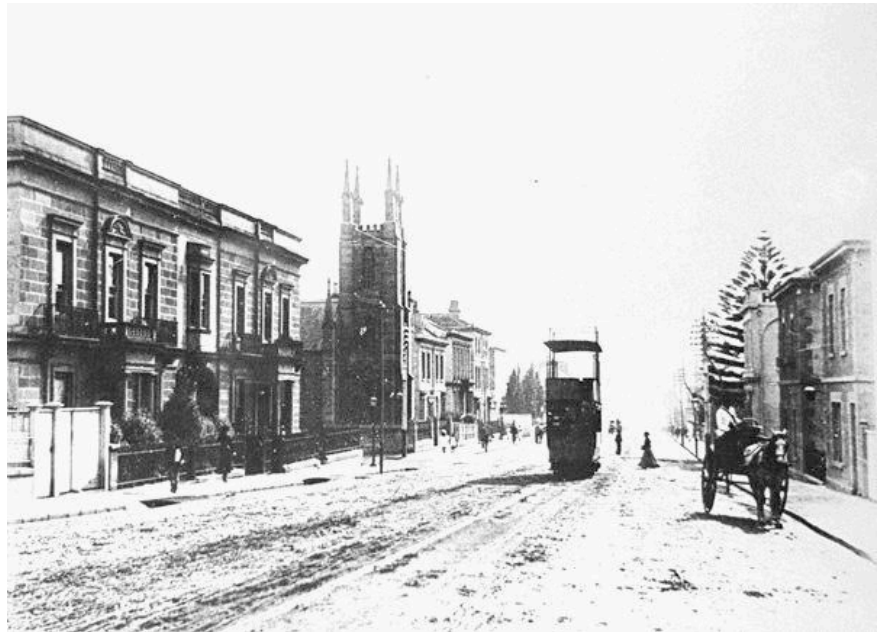
**Figure 15**

'Macquarie Street t looking east', ND but c1895. Photograph. Note that the masonry wall to the Street frontage has been replaced with an ornamental cast iron fence. *SLT WLC Library*.

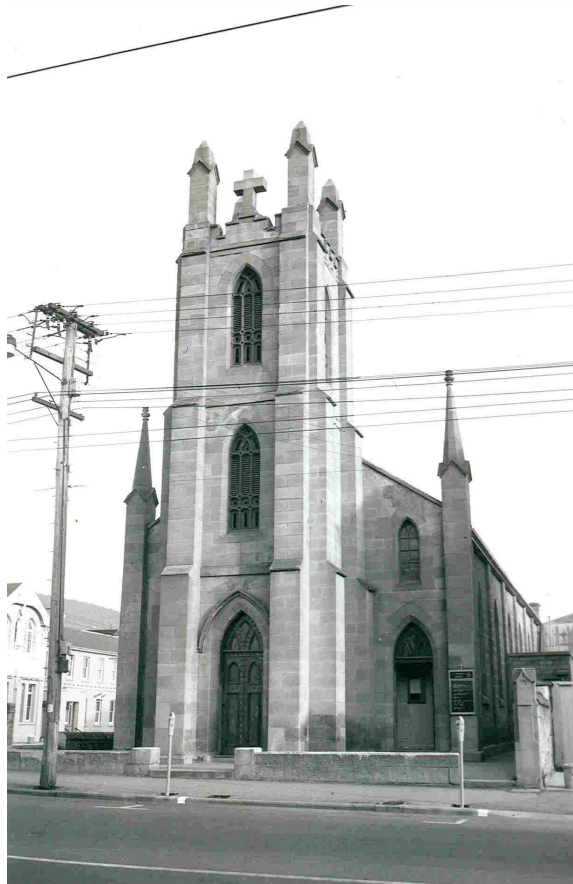
**Figure 24**  
'St Josephs Church', ND but c**1960**. The cast iron decoration to the front wall has been removed. *StJ Archive.*

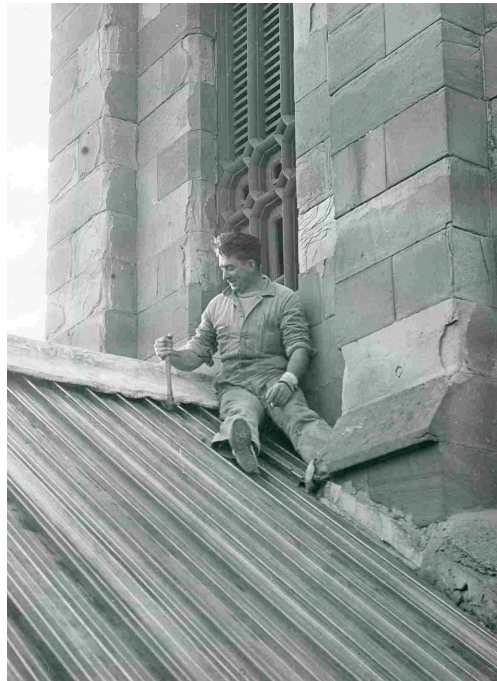
**Figure 27**

*'Inspecting the Church fabric.'* **1968.** The stone is obviously in poor condition. Note that the slate roof has been replaced with a steel tray roof. *StJ Archive.*

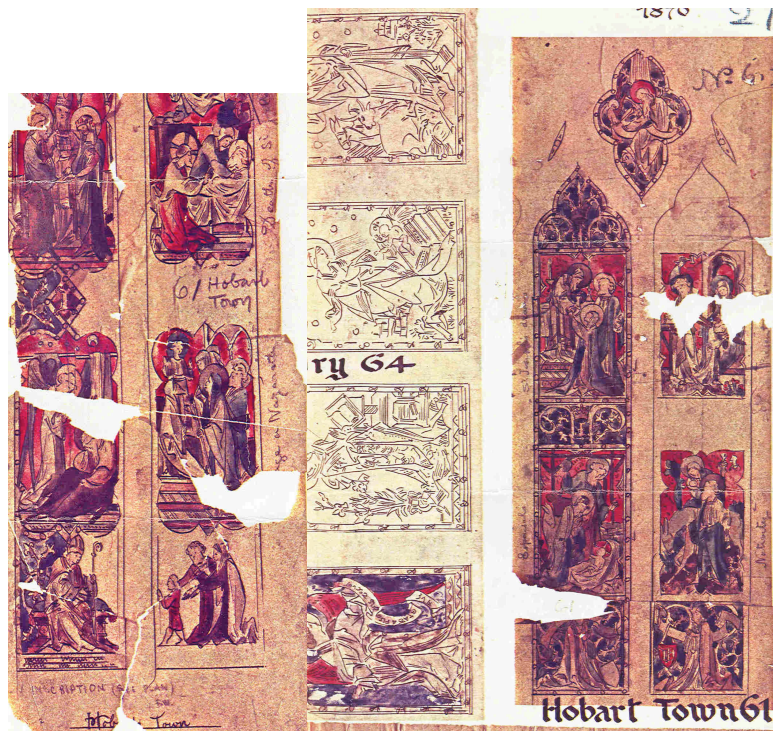
**Figure 30**

Design for the 1870 stained glass. This a modern photocopy from the Hardman archives.

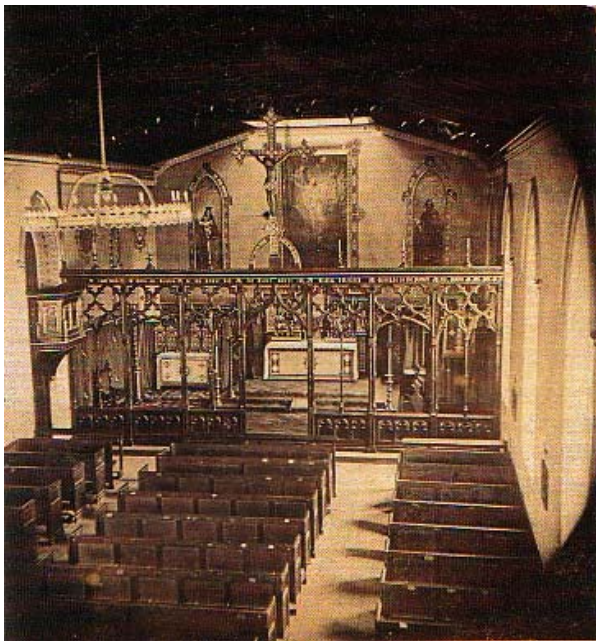
Photograph by Sharp dated c.1859 that was published in Brian Andrews' 'Building a Gothic Jerusalem'.

The circa 1859 scheme (illustrated left) included soft blue distemper painted walls and a strong blue colour on the walls of the chancel area beyond the rood screen. The chancel was decorated with a frieze and dado and decorative motifs. The dado had large medallions and the three canvases on the end wall behind the altar were framed in painted borders that appear as frames to the paintings. A scoll of running script formed a frieze on the end wall.

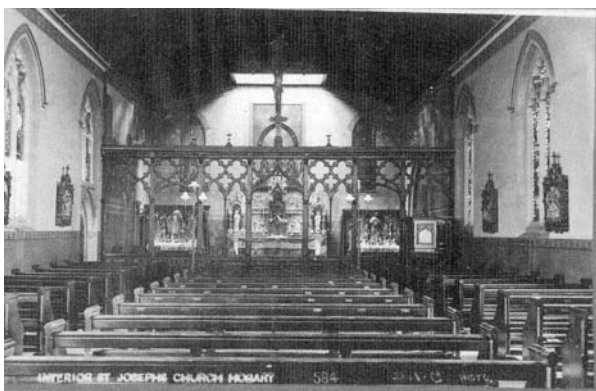
View of church after the scheme by Fagg was completed and the Sheppard murals were added in 1899. DE photo 2005.

Photographs from several sources show an even more elaborate scheme of painted decorations that was introduced in the 1890s. The scheme that was designed by George Fagg had a strong aesthetic character. It was based on tertiary paint colours including olive green and salmon and it was more comprehensive in the extent of decorations. The dado was richly patterned and the wall filling in the chancel area was diapered with lines and medallions. There was extensive gilding throughout.

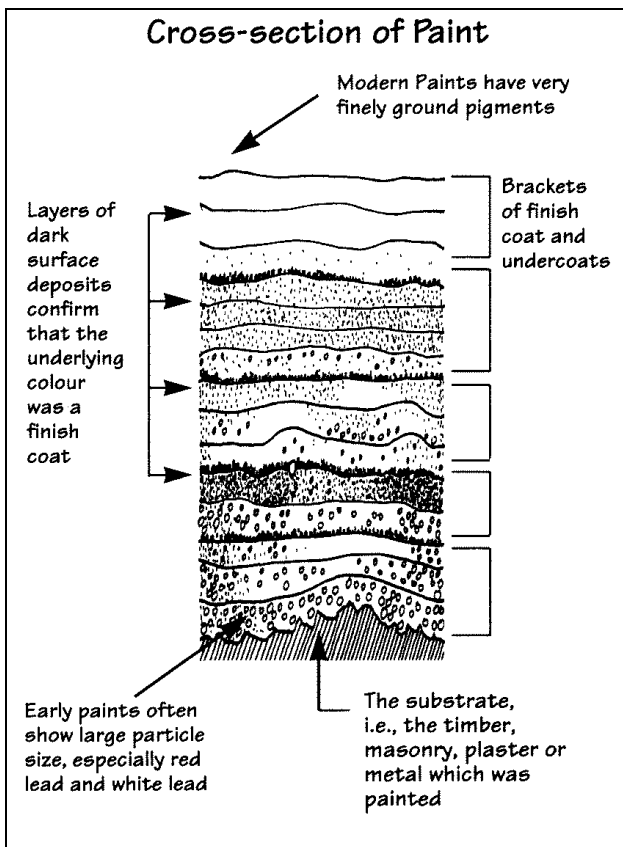
Illustrations of the research and analysis by the cross sectioning process. Drawn DE.

The process of layering is used to determine the nature and sequence of finishes on building fabric. In most cases finishes such as plaster, paint, wallpaper and the like are layered sequentially in a continuous process of adding. It was unusual for old finishes to be removed prior to the application of a new finish because this simply added to the amount of work required to complete the job. The common nature of layering therefore enables a re-examination of the sequence of finishing by a process of cross sectioning by which means the layers can be viewed and recorded as indicated in the illustration at left.

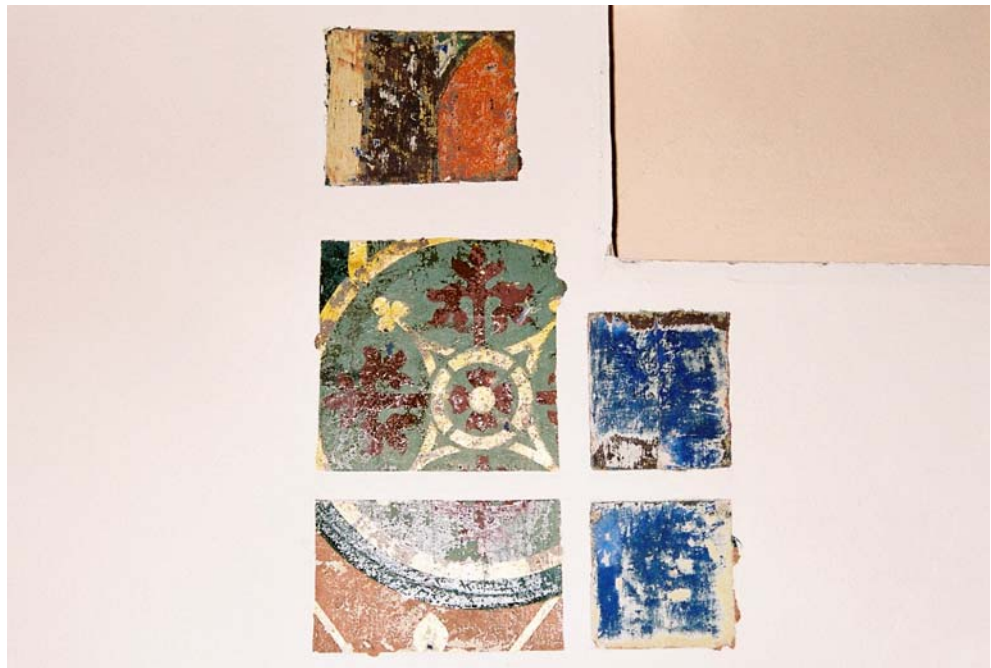
View of windows that were made on the rear wall of the chancel by removing overlayers of paint to reveal details of the early schemes of decoration. DE photo 2005.

The two small squares of strong blue in the right of the view above are examples of the circa 1859 scheme as is top window showing red and brown, which are the colours of the border that was painted around the central canvas wall painting in 1859.

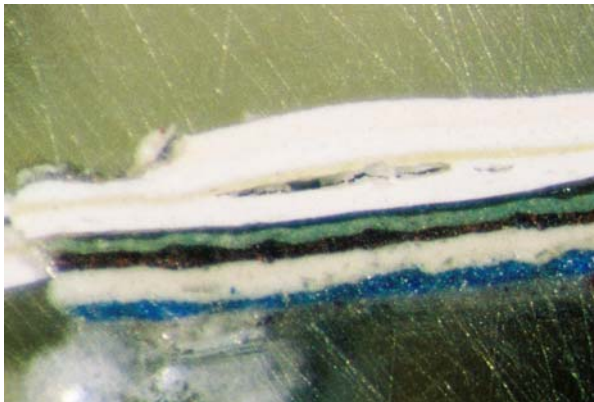
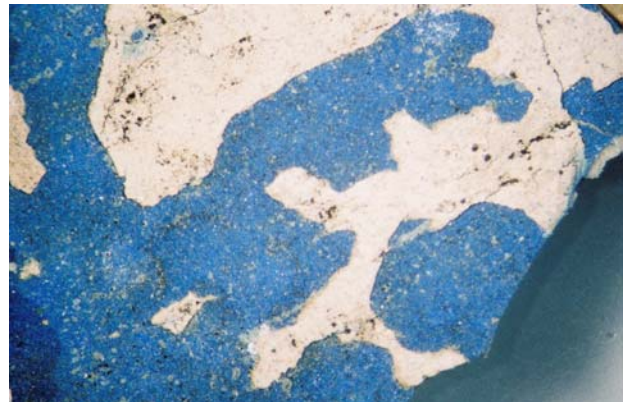
Cross section through the paintwork on the rear wall of the chancel (below left) and a magnified view of a flake of paint showing the strong blue distemper paint and earlier layers of white and traces of green. DE photos 2005.

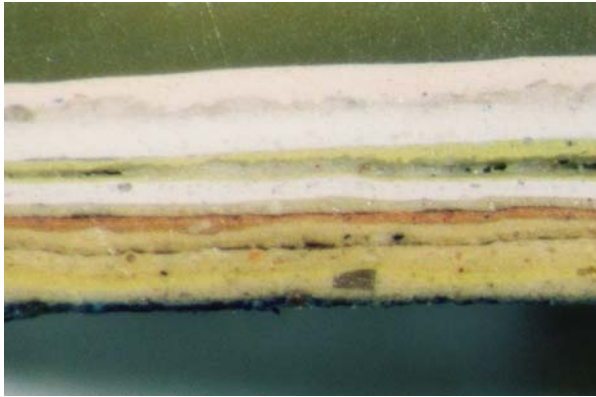
Sample of flaking paint from the end wall of the chancel. DE photo 2005.

The sample at left was taken from the end wall of the chancel above the modern timber wall panelling. This sample does not include any but a thin layer of blue at the bottom of the sample. It is a sample of the composite of paint finishes that breaks away easily from the wall surface at the blue layer of distemper which is a weak layer in the paint composite. The sample does not show the earliest paint layers (i.e. it does not show any of the paint finishes that were on the wall before 1859.

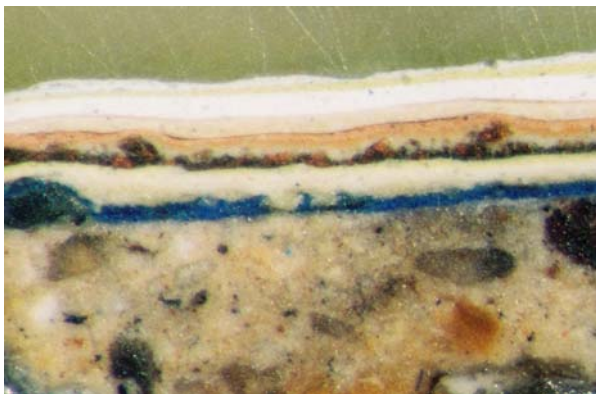
The blue layer in the sample at left sits above an emerald green colour that is visible at the bottom of the layer of blue. The green is above a layer of light cream or white. The green and white pre-date the blue. The plaster finish is itself coloured, indicating that the very first finish might have been the natural plaster.

The layers above the blue are durable oil paint finishes.

Sample from the end wall of the chancel at the top of the timber panelling. DE photo 2005.

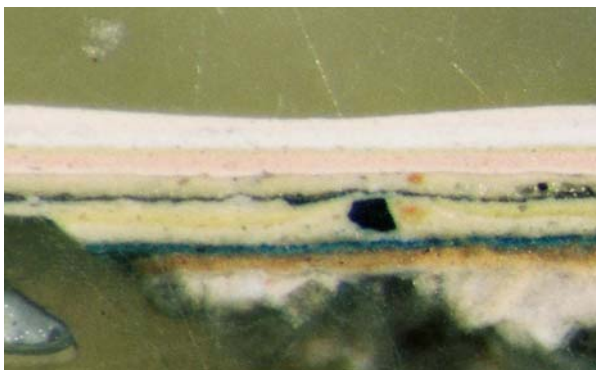
In the sample at left (top) shows the strong blue colour of the 1859 decorative scheme can be noted below the black impurity. It sits above two earlier colours; near white and light stone.

On top of the blue there are two layers of colour and a dark line representing the Benjamin Sheppard mural. These are covered by a number of light pastel shades representing the post 1940 paint finishes.

Sample from the side wall of the chancel reveal further details of the painting history. DE photos 2005.

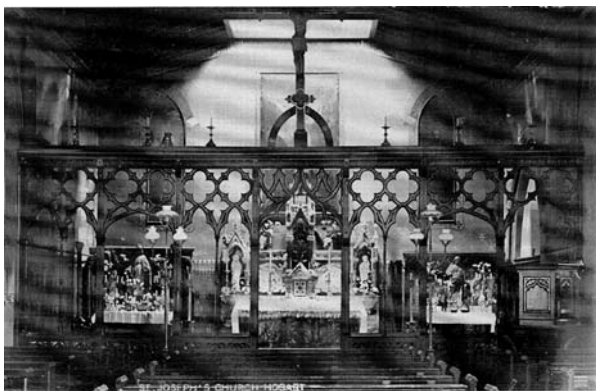
Detail from c.1899 photo showing the lantern and wash if light below.

The church is unusual in having a roof lantern above the altar. It is a feature that shows in the earliest photograph (1859). Like the roof timbers this area was not able to be examined and therefore no information was collected. However it could be noted from floor level by observing the pattern of reflected light that the walls of the light shaft to the roof lantern are lined with a fabric (possibly canvas) and that the fabric was painted and decorated with large medallions at least, similar to wall medallions.

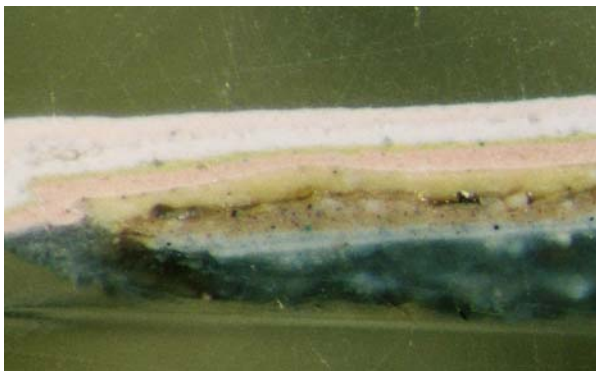
The walls of the nave were finished in a soft blue distemper when the chancel was painted in the strong blue distemper. This soft blue distemper and similar distempers appear as the bottom layers in the sample at left taken from the south wall of the nave, above the dado. There was no division (i.e. there was no timber panelling or painted dado) on the walls of the nave in 1859, or at least none that shows in the photograph from that time.

Samples from the wall (top) and dado (below) of the nave. DE photos 2005.

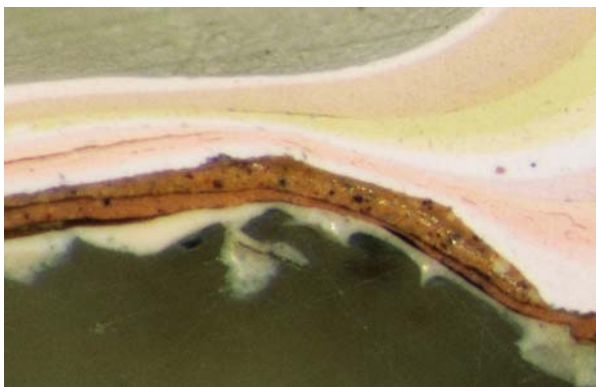
The dado that appears in the 1899 photo was painted in a mid brown oil paint with a decorative border. At least two brown dados were painted as illustrated in the sample at left, taken from the dado area on the south wall of the nave.

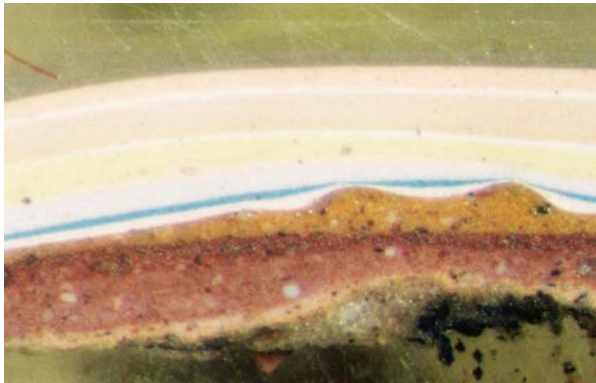
The paint layering includes layers of light stone (the earliest paint finishes) followed by Venetian red (probably relating to the 1899 scheme of decoration) and tan, followed by pastel and light colours.

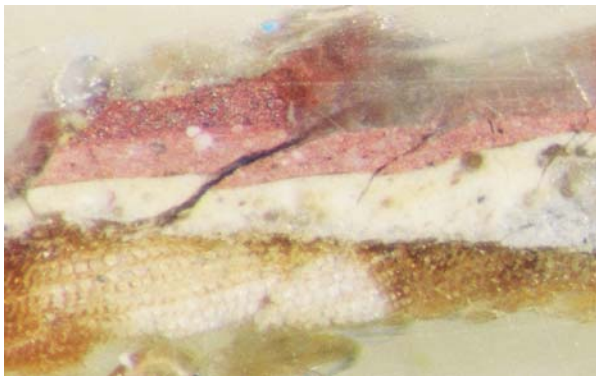
Photomicrographs of paint samples taken from the joinery of the gallery at the rear of the nave. The top and bottom photos show the same layering. DE photos 2005

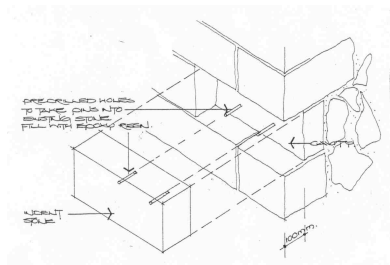
DETAIL A Indent Repair

Cut out existing sandstone to a depth of bearing on stonework below of 100mm. Apply Westox Cocoon, as per manufacturer's recommendation, to remaining indent repair stone in situ, for a period of approximately one week. Poutlice to be applied only to repair stone, surrounding stonework to be protected from splash and overrun. Insert new damp proof course to top joint of repair stone. Prepare recesses in new and remaining stone on bed, to take fishtail stainless steel cramps or stainless steel threaded rod set in epoxy resin, for

connection of new to remaining existing stone. Clean out voids and dampen surrounding surfaces. Set new indent repair, dampened, onto bedding mortar. Repoint the joints to match existing.

Indent repairs carried out where stones in a flat wall face have deteriorated more than 10mm behind the wall face. All indent repairs are to be confirmed on site with the Principal's Representative and clearly recorded prior to works
